ERADICATING EXTERNAL PIPE CORROSION

Hani Almufti
and Yulman
Flores,
Cogbill
Construction,
USA, discuss
protecting
above-
ground piping
systems
from external
corrosion
under pipe
supports.

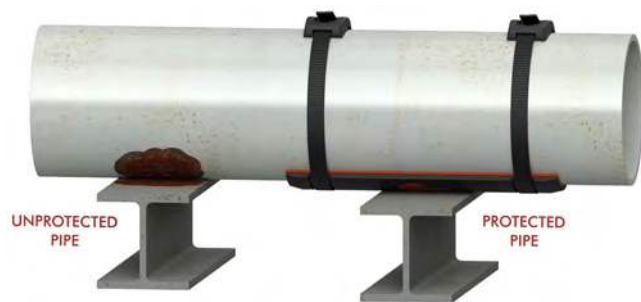
Figure 2. Installed RedLineIPS SmartPad protects piping from external corrosion.

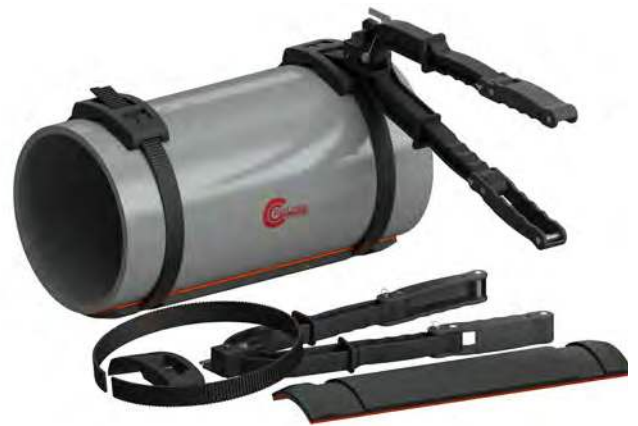
Figure 3. RedLineIPS SmartPad System components.

- The SmartPads themselves are all-composite FRP wear pads with special design modifications, including

two recessed grooves to allow our SmartBands to sit recessed into the pad's body. The recesses anchor the bands firmly in place while protecting them from being damaged by the pipe's supporting structure.

- A closed-cell Hydroseal gasket is pre-installed on the inner surface of each SmartPad. These gaskets are capable of offering NEMA 4-level watertight seal when compressed.

- The SmartPad, with its Hydroseal gasket, is placed underneath the pipe at the pipe support point, to isolate it from its supporting structure.
- The gasket, which resembles a memory foam mattress, protects new pipes as well as those that have pits and valleys due to remedied corrosion.

- Composite SmartBands are looped around each SmartPad into the recessed grooves, and composite buckles are attached to the SmartBands.
- Our SmartTool is then used to easily apply a high rate of tension to tighten the SmartBands, thus compressing the Hydroseal gasket. This, along with the pipe's compressive load, cause the gasket to create a NEMA 4 watertight seal at the contact surface, effectively eliminating the possibility of moisture ingress between the pad and the pipe.

- Finally, the built-in clipping mechanism of the SmartTool is used to cut off excess banding.
- The installation process takes only seconds.
- The SmartPads can be removed in seconds to visually inspect the pipe for external corrosion by cutting off the SmartBands. They can then be reinstalled, again in seconds, using the original SmartPad and gasket, but new SmartBands, an inexpensive component.

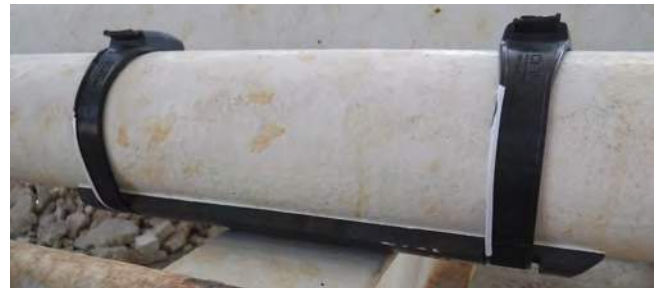
Figure 4. Installed SmartPad with Teflon (white) strips to protect it from highly-corrosive chemicals.

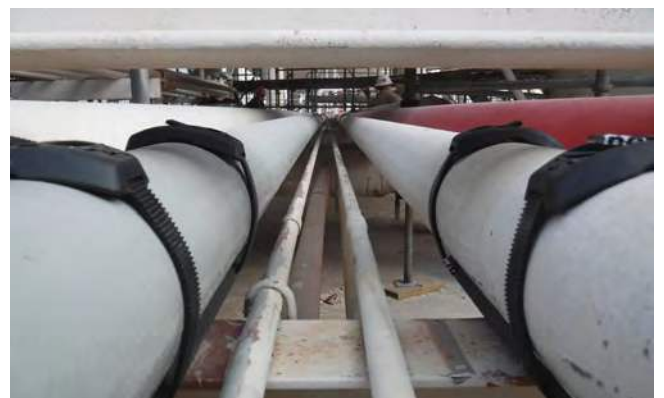
Figure 5. Standard SmartPads installed in a chemical plant in the Gulf of Mexico.

Notably, a chemical plant at the Texas Gulf Coast, in immediate proximity to the Lavaca Bay, was faced with ageing and damaged pipelines due to exposure to humidity, caustic chemicals, and salty air. Numerous sections of the pipelines in the older units were installed directly on the supporting steel structures without any buffer material in-between to protect them from corrosion.

Cogbill's SmartPad System incorporates a compressible gasket into its design that could conform to the uneven surface of a corroded pipe, which effectively seals any moisture or contaminants out of the damaged area. This would stop corrosion and prevent future damage, without the use of epoxy or welding or the need to shut the lines down to grind the pipes to a smooth surface condition.
